FACILITY COMPLIANCE INSPECTION REPORT

Date of Site Inspection: 20 January 2012

Miller Farm LCID Landfill
Miller Farm Road
Morehead City, NC 28557

N0190, 012012

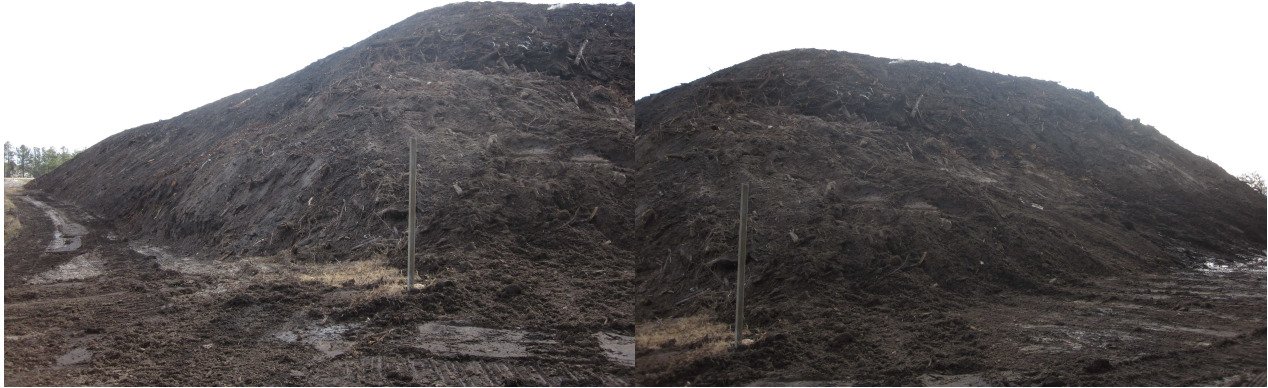
Sideslopes in need of cap repair-seeding and mulching

- 18) *As soon as is **safely practicable**, please resume compacting and covering the landfill cap and sideslopes damaged during the fire incident. Once the repairs are completed, all sideslopes should be graded at a slope not greater than 3:1 and seeded and mulched to establish a groundcover suitable to prevent erosion.
